Section 2. PLANT SURVIVAL

Section 3. CHANNEL STABILITY

UT to Dixon Branch

Site 24

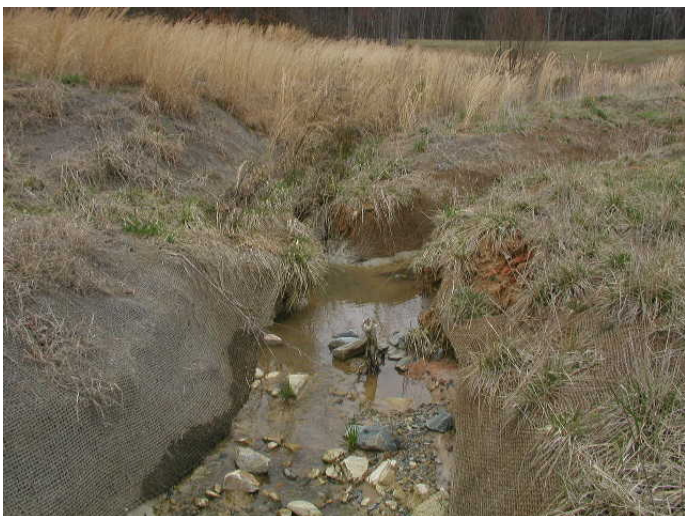
Photo Point #3 (Upstream)
Year 2 Winter – March 2010

UT to Dixon Branch (Site 24) stream relocation has experienced some instability prior to the Year 2 Winter evaluation. The stream bed has down cut around Sta. 380+40 which can be seen from Photo Point #3. Some minor bank erosion around some of the rootwads was noted from Sta. 378+15 to 379+40. Some erosion was noted along the cut slope at Sta. 379+00. A bankfull event had occurred on site since the last monitoring evaluation. NCDOT plans to perform remedial work at this stream relocation to repair the unstable areas.

Estimated causes, and proposed/required remedial action: NCDOT proposes to replant Type II plantings throughout Site 24. Live staking should take place wherever missing or dead stakes are found. This should take place following the remedial work on the stream relocation.
